Surge Voltages in Residential Power Circuits

G.J. Hahn
General Electric Company
Schenectady NY

31 CP 67-430

SURGE VOLTAGES IN RESIDENTIAL POWER CIRCUITS

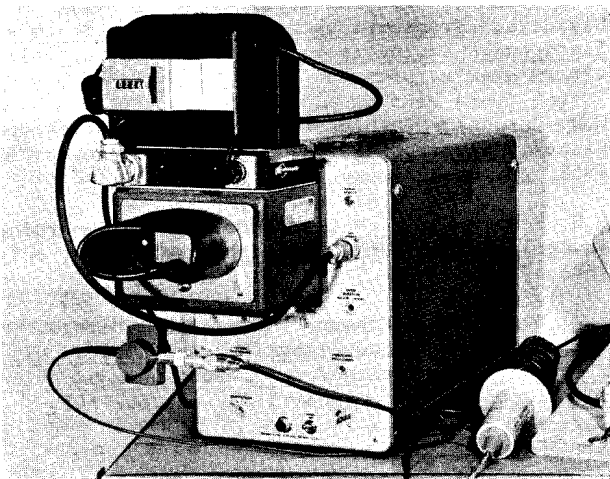
Figure 1. Oscilloscope and Camera

In cooperation with Tektronix, Incorporated, a type 515 cathode ray oscilloscope was modified to record transients on film, with automatic advance of the film after a recording.

The camera, attached to the scope bezel, is a Beattie-Coleman system, accommodating 100 feet of 35 mm film, with no shutter, and recording on a 24 x 36 mm frame the trace displayed on the CRT. Following the sweep, the contact mentioned above closes the motor circuit, advancing the film to the next frame in a few seconds. This film transport duration is matched in the oscilloscope trigger circuit by a hold-off so that no sweep will occur during film advance.

Figure 1 is a photograph of this oscilloscope camera system. The relatively high cost of this system, its conspicuous presence (e.g., size, camera noise, etc.) in a home, and the amount of film to be scrutinized frame by frame limit the number of locations at which recordings can be made. However, for conclusions to rest on a sound statistical basis, it is necessary to investigate a large number of locations. To be acceptable to cooperative home owners, a transient detector should therefore lend itself to inconspicuous installation and simple data handling. Thus, a device which can merely be plugged into a wall receptacle, and that has a digital counter indicating the number of surges occurring above a specified threshold is satisfactory for widespread recording.

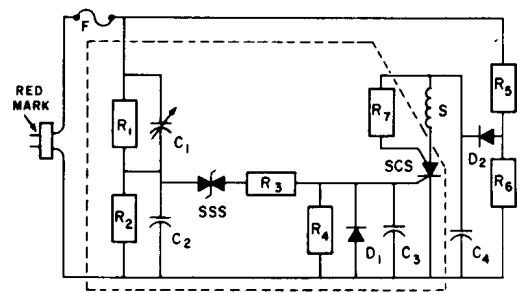
Figure 2. Surge Counter Circuit

The circuit shown in Figure 2 was developed for the purpose, and packaged as shown in Figure 3. This device is connected to a wall receptacle by a conventional appliance cord, not a special probe. This connection is simple, establishes a typical final path for a surge impinging upon any appliance connected to this particular wall receptacle, and provides power for the high impedance rectifier circuit and a signal input to the trigger-sensor circuit.

A crudely compensated divider ($R1C1/R2C2$) attenuates the incoming surge before application to the Silicon Symmetrical Switch (SSS). This device has the characteristic of turning on abruptly whenever the voltage across it reaches a threshold, such as 250 volts. This threshold remains constant for durations as short as 0.1 μ s. When the SSS turns on, the attenuated surge is applied to the gate of the very sensitive, fast switching Silicon Controlled Switch (SCS). If the polarity of this surge is positive, the SCS turns on,

allowing the capacitor C to discharge through the coil of the solenoid-actuated counter S. A high impedance (50,000 ohm) divider and half-wave rectifier provide a trickle charge 15-volt supply for the capacitor C. The resistance of this divider represents a negligible load for the house wiring system, yet is sufficiently low to allow some leakage in the electrolytic capacitor C. The long charging time (several seconds) of the capacitor is not objectionable, since the transients to be detected do not have a high repetition rate.

Calibration of the circuit is obtained by adjusting the value of the divider ($R1C1/R2C2$). In these tests, the threshold level was set at 1200 volts for one group of counters and at 2000 volts for another group. A bench circuit was set up, whereby a surge with adjustable level and duration could be superimposed on a 60 Hz, 120-volt power supply. Some consideration was given to the need to segregate, or filter out, the surge from the 60 Hz power voltage; in this case, however, with the minimum level at 1200 volts, the base 170-volt crest represented a small contribution and was included in the signal detected by the circuit. Surges with approximately flat top and durations from several microseconds to 0.2 microsecond were applied to determine the variation of the threshold voltage as a function of surge duration. A typical response curve is shown in Figure 4. The response of this crest-indicating counter can be considered satisfactory, since the oscilloscope recordings in homes, as will be discussed later, have indicated that the shortest half-period of oscillatory surges is in the order of 2 microseconds.

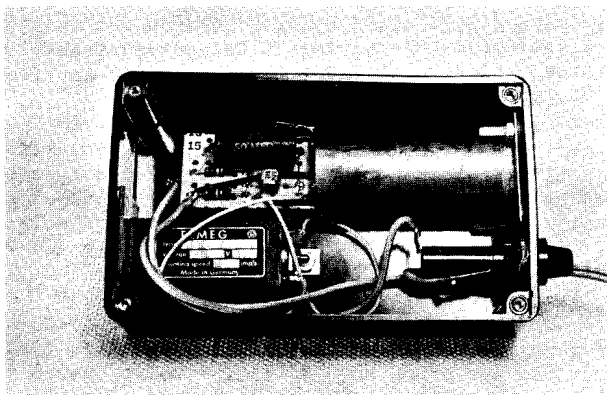
Figure 3a. Surge Counter--Cover Removed

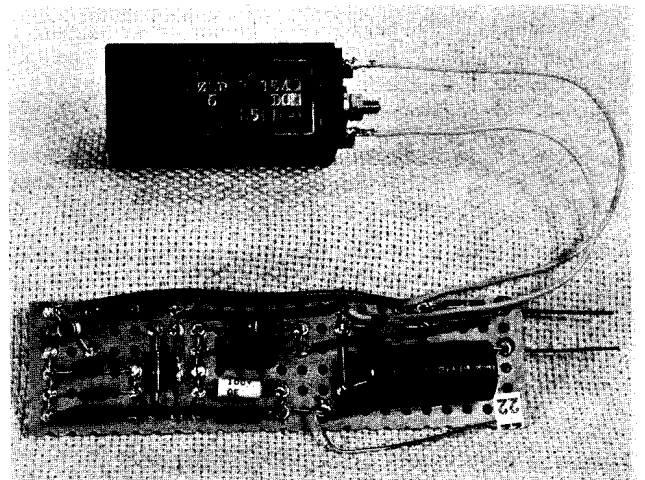
Figure 3b. Surge Counter Elements--Removed from Shield

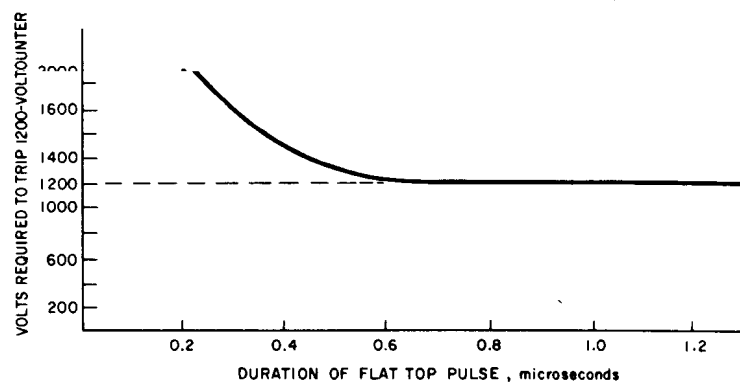
Figure 4. Response of Surge Counter

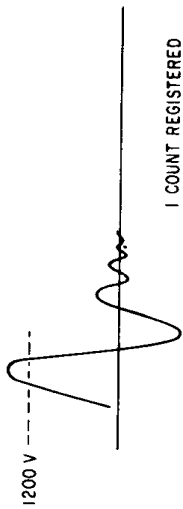
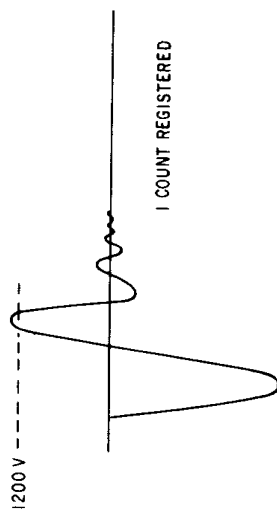
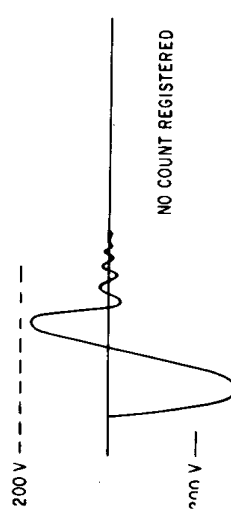
Figure 5. Recording of Surge with Single Polarity Counter

The surge counters record only one polarity; in order to minimize record keeping by the homeowner, the connection of the cord was not polarized. In the event of an oscillatory surge (which is always quickly damped in these systems) two cases of counting can occur. For instance, the high side of the divider can be connected to the "hot" terminal of the receptacle (Figure 5). If the first half-cycle is positive and exceeds 1200 volts, a count is registered. If the first half-cycle is negative, and the second, positive half is highly damped, no count is registered. If the first half-cycle is well above 1200 volts causing the second half, in spite of some damping, to exceed 1200 volts, a count is registered. For the reverse connection, the same would occur for reverse polarity. Thus, the actual number of surge occurrences of both polarities in excess of 1200 volts is between 1 and 2 times the number indicated by the counter. The objective of the recording in this test series was only to determine whether or not surges occurred rather than their exact number. Consequently, the value of the multiplying factor is not very significant.

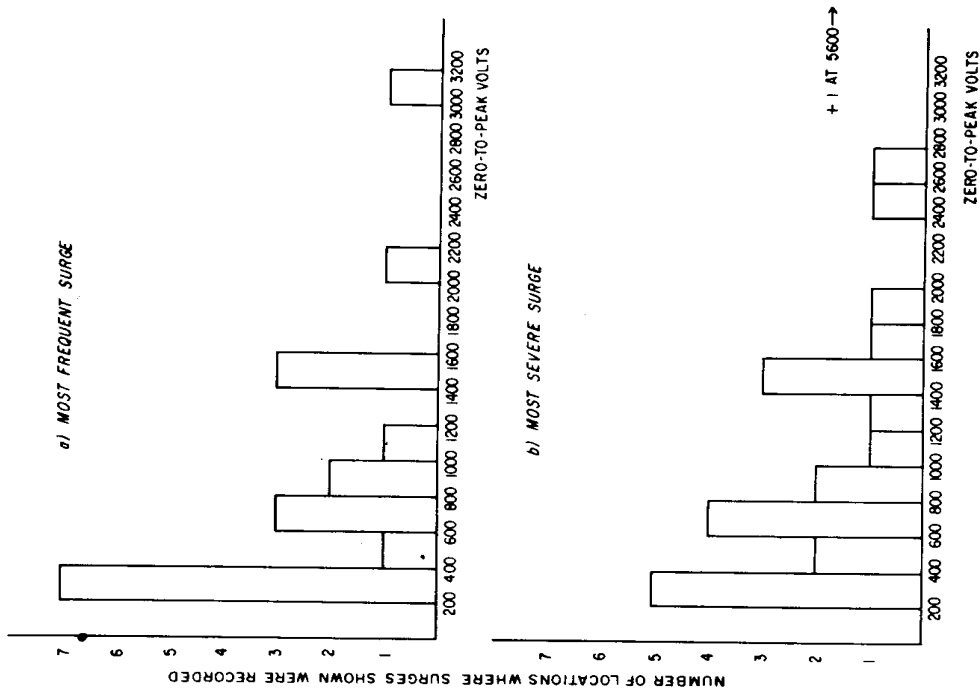
Figure 6a. Distribution of Surges--Most Frequent Surge

Figure 6b. Distribution of Surges--Most Severe Surge

At the conclusion of the recording program, a total of 16 homes and two overhead distribution poles had been monitored for a total of 7000 hours. The peak of the surges was distributed as shown in Figure 6a; the most frequent and severe surges were distributed as shown in Figure 6b.

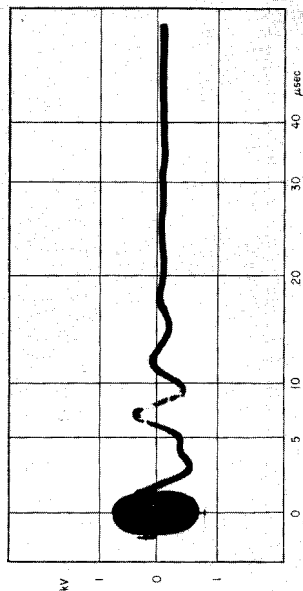
Figure 7a. Internal Switching Transient Recorded at a Farmhouse (15 such transient surges in 1500 hours)

1. Load switching in the house occasionally produced transient surges; these affected only that particular house. For any particular house, these transient surges had a wave shape which was consistently repeated with variations in amplitude along the entire film recording. This probably resulted from combination of switch characteristics and the impedance of the house wiring system; the variations in amplitude were probably caused by variations of the switching angle and/or connected loads. Typical wave shapes of the recorded surges are shown in Figures 7a, 7b, and 7c.

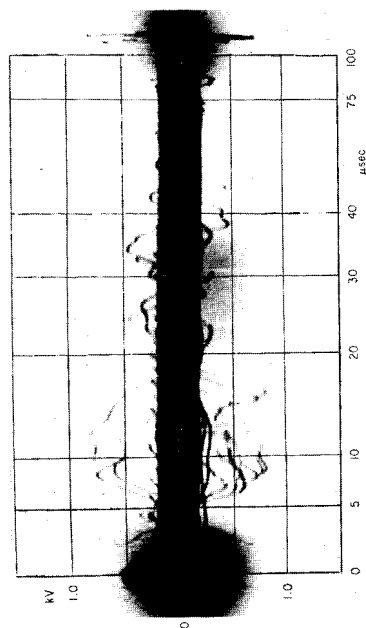
Figure 7b. Composite Record Showing Surges for a 24-hour Period at a Suburban Home. (Oscilloscope is triggered for each surge, plus once every hour, resulting in \pm 165-volt band of steady state 60 Hz voltage. Recordings above 1800 volts are blanked out by the oscilloscope.)

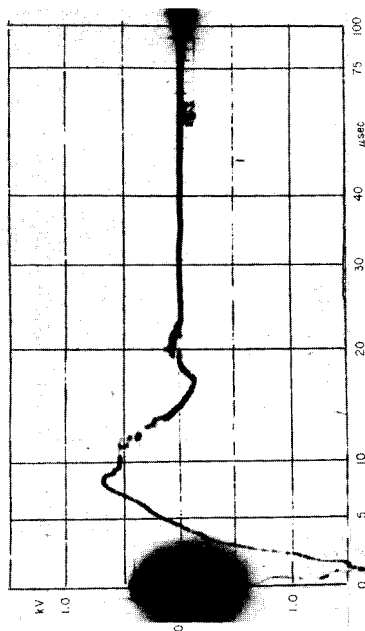
Figure 7c. Single Surge with 1700-volt Peak, Recorded at the Same Location as Figure 7b. (In a 5-day period surges of this wave shape were recorded as follows: 13 above 1000 volts, 18 above 1500 volts, 21 above 2000 volts, and 1 above 2500 volts. Source was determined to be interruption of a high-voltage transformer for an oil furnace.)

In one case, it was possible to install an oscilloscope in a house adjacent to that where repetitive surges up to 1700 volts were being recorded. The service drops were connected to the same pole, yet no surges occurring simultaneously were recorded in the second house.

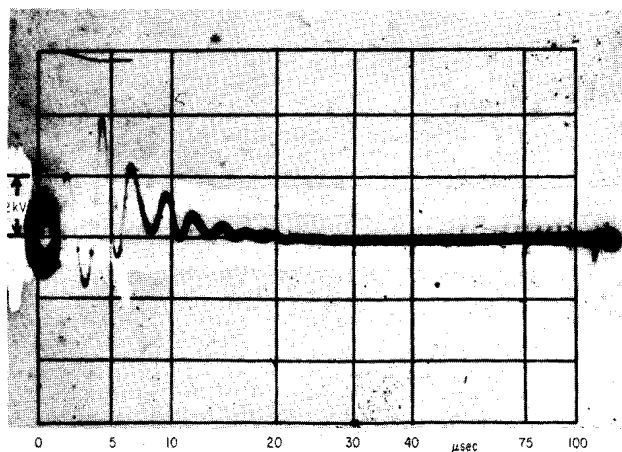
Figure 8a. Transient Surges Recorded on Overhead Distribution Systems in Charleston, South Carolina (3800-volt crest, 300 kHz oscillation.)

2. Surge voltages not associated with load switching within the house were associated with lightning storms. In some cases, the home owner was able to correlate the film advance counts with the storm. Although recorded during lightning storms at two different locations, the surges shown in Figures 8a and 8b present the interesting characteristic of being oscillatory at a frequency in the range of 300 kHz. The surge shown in Figure 8a was recorded at the overhead distribution line (oscilloscope mounted on the pole), while the surge of Figure 8b was recorded at the service entrance in a home. The first exhibits far less damping than the second; this might be explained by the lower damping due to lower resistance of the system at the pole than at the end of a service drop.

Both of these surges, as well as most of the other surges recorded during lightning storms, exhibit this oscillatory characteristic at a frequency which is nearly constant for a particular locality. This constancy suggests that the oscillation of the system followed an excitation caused by the lightning stroke. A number of surges in the range of 800 to 1200 volts were observed during several storms. The maximum surge voltage recorded was 5600 volts; several other surges recorded during the same period were in excess of 4000 volts.¹

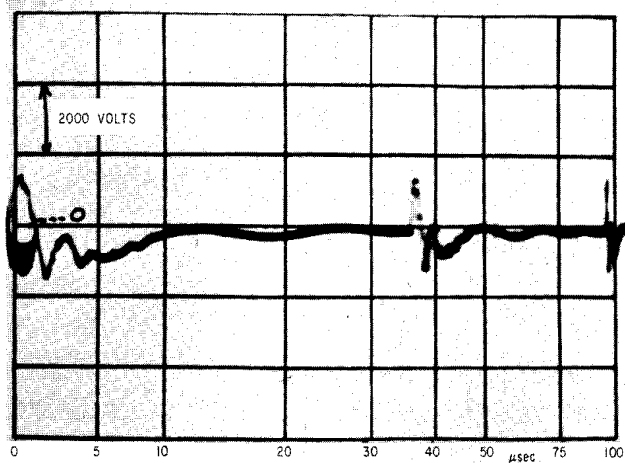
Figure 8b. Transient Surge Recorded at the Service Entrance of a Home in Florida
